## TECHNOLOGY BULLETIN

JUNE 1998 FORESTRY REPORT R8-FR 63  
USDA FOREST SERVICE / SOUTHERN REGION  
1720 PEACHTREE RD., NW ATLANTA, GA 30367  
SOUTHERN RESEARCH STATION  
320 GREEN STREET, ATHENS, GA 30602

### HOW TO PROTECT TREE ROOTS WHILE REPLACING SIDEWALKS AND CURBS

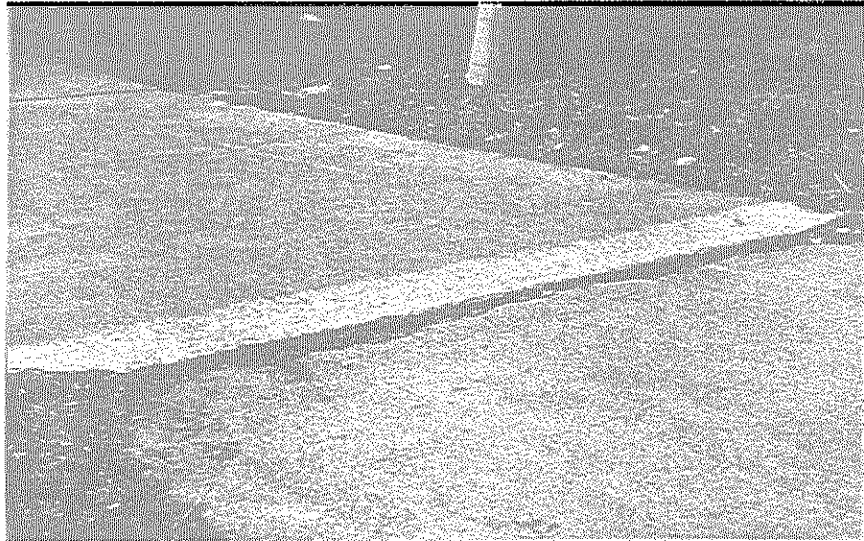
Another simple, low-cost alternative for repairing a displaced sidewalk is the use of a mechanical grinder to wear down the raised edges of the slab (fig. 2). Grinding is generally limited to concrete slabs with less than 1 inch of displacement. It may be possible to grind away edges with 2-inch displacement; however, if 50 percent of the slab thickness is removed, the structural integrity of the concrete may be lost.

Figure 2. Mechanical grinding

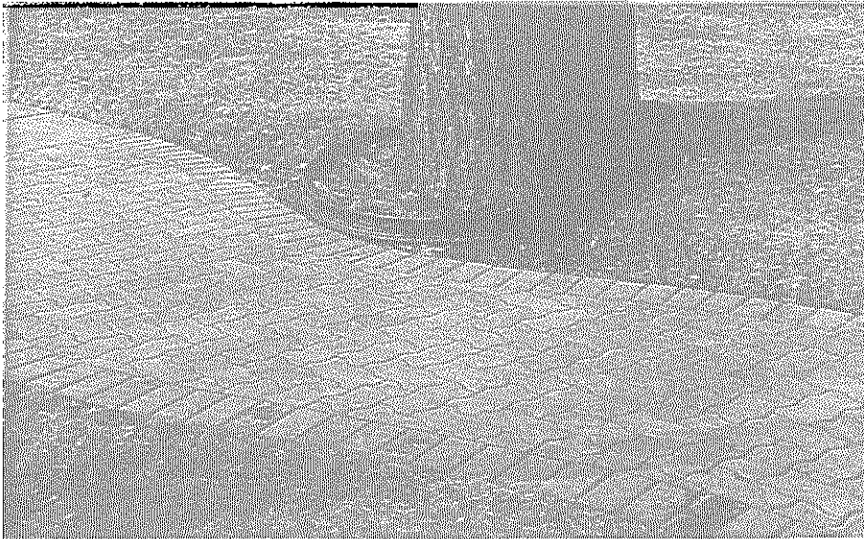
Removing the damaged sidewalk and installing landscape pavers is a very attractive option, but the high unit cost can prohibit this type of repair in most communities (fig. 3). In addition, as roots begin to expand, individual pavers could easily be displaced and would require repair.

Figure 3. Landscape pavers

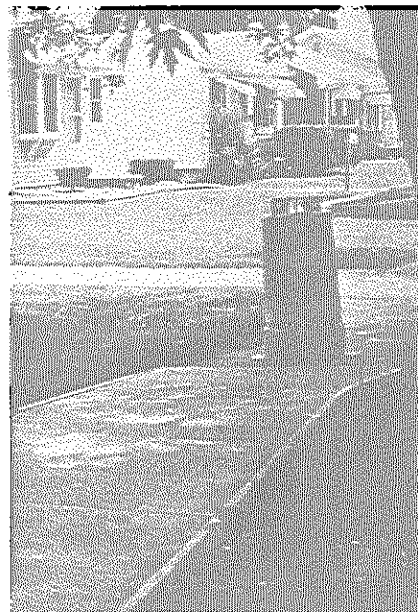
Another option is to remove the damaged sidewalk and install a concrete ramp. The concrete is then poured over the top of uncut roots to create a ramp (fig. 4). Unit cost and material durability are reasonable; however, concrete is a stiff material that can be expected to lift as individual tree roots expand.

Figure 4. Concrete ramp
