# Vegetation Risk Management Plan *Template*

## ***Step 1 -- Introduction***

Introduce the Vegetation Risk Management Plan (VRMP) and its purpose.

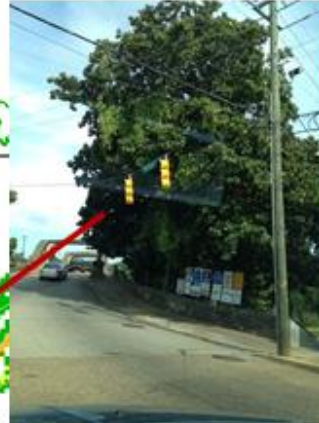
## UTRI – Wetumpka

Example 2: The image that follows demonstrates the area in Wetumpka that is located near the downtown business district on a major transportation corridor. This area is a

highly populated area with several critical facilities including the 911 Emergency Management Agency. Also shown is the presence of tree canopy that has a need for annual inspection to evaluate the likelihood of tree failure.
